Worcester Central School District

2015 Building Condition Survey Presentation

Scott Duell, RA, LEED AP
BCA Architects & Engineers
WATERTOWN | ITHACA | SYRACUSE

December 16, 2015

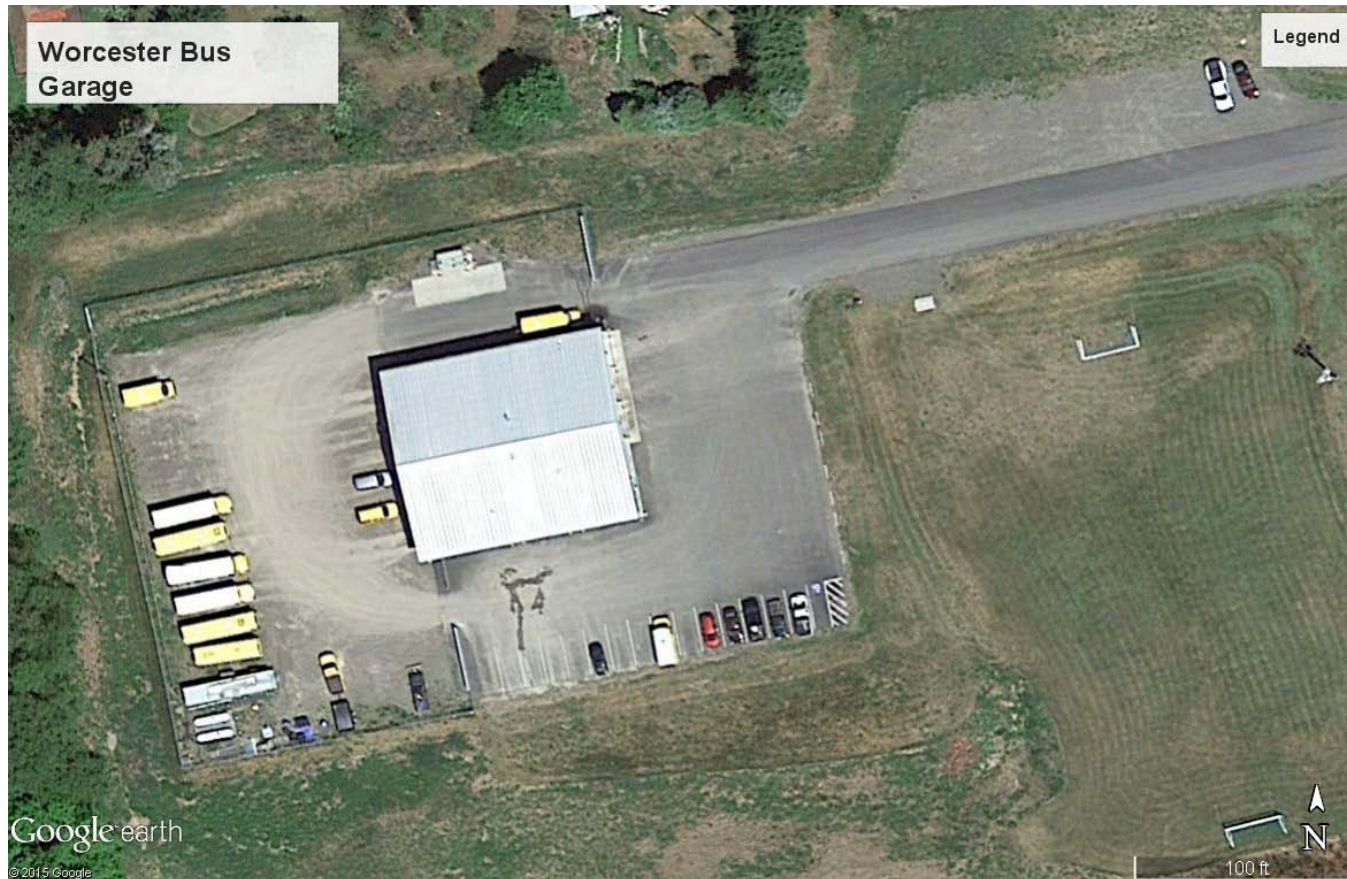
Bus Garage – Key BCS Findings:

1. Fire Alarm Systems:

- Add CO detection to meet current NYS code - *estimated at \$10,000.*

2. Emergency / Exit Lighting Systems:

- Add emergency battery-backup power wall packs throughout the building to provide egress path – *estimated at \$18,000.*
