# Worcester Central School District

## *2015 Building Condition Survey Presentation*

**Scott Duell, RA, LEED AP**  
**BCA Architects & Engineers**  
WATERTOWN | ITHACA | SYRACUSE

**December 16, 2015**

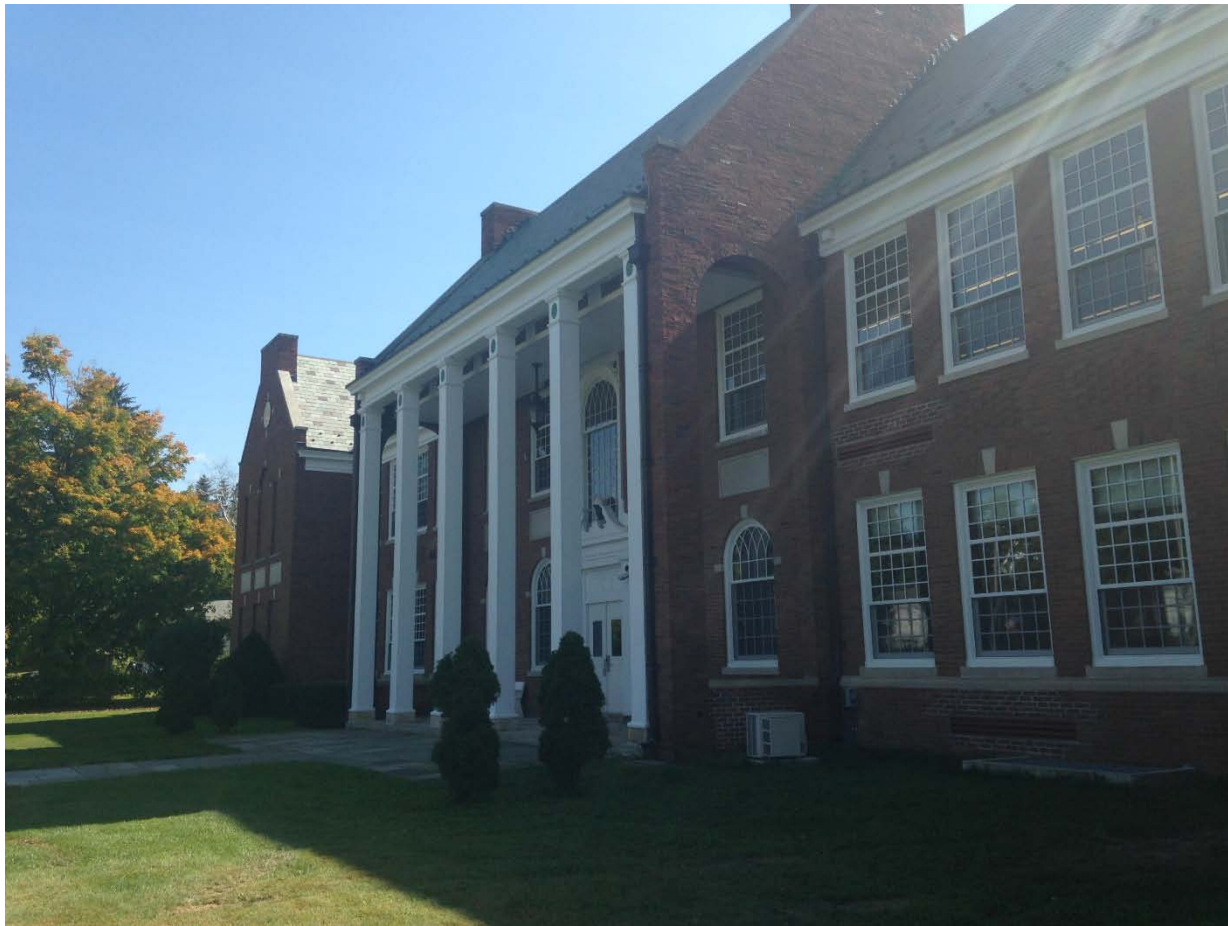
## Main Building – Key BCS Findings:

- The porous pavement installed in 2013 is degrading. Porous paving requires a higher grade binder to hold it together, if you were to re-mill / resurface – *estimated at \$475,000, but since it is so new SED would most likely not aid this work.*

- The modified bitumen roof over the 1981 portion of the building is nearing the end of its useful life. Consider replacing with new EPDM roof with 30 year warranty – *estimated at \$460,000.*

- Add CO detection to meet current NYS code – *estimated at \$15,000.*

- Add emergency battery back-up lighting fixtures building wide – *estimated at \$36,000.*

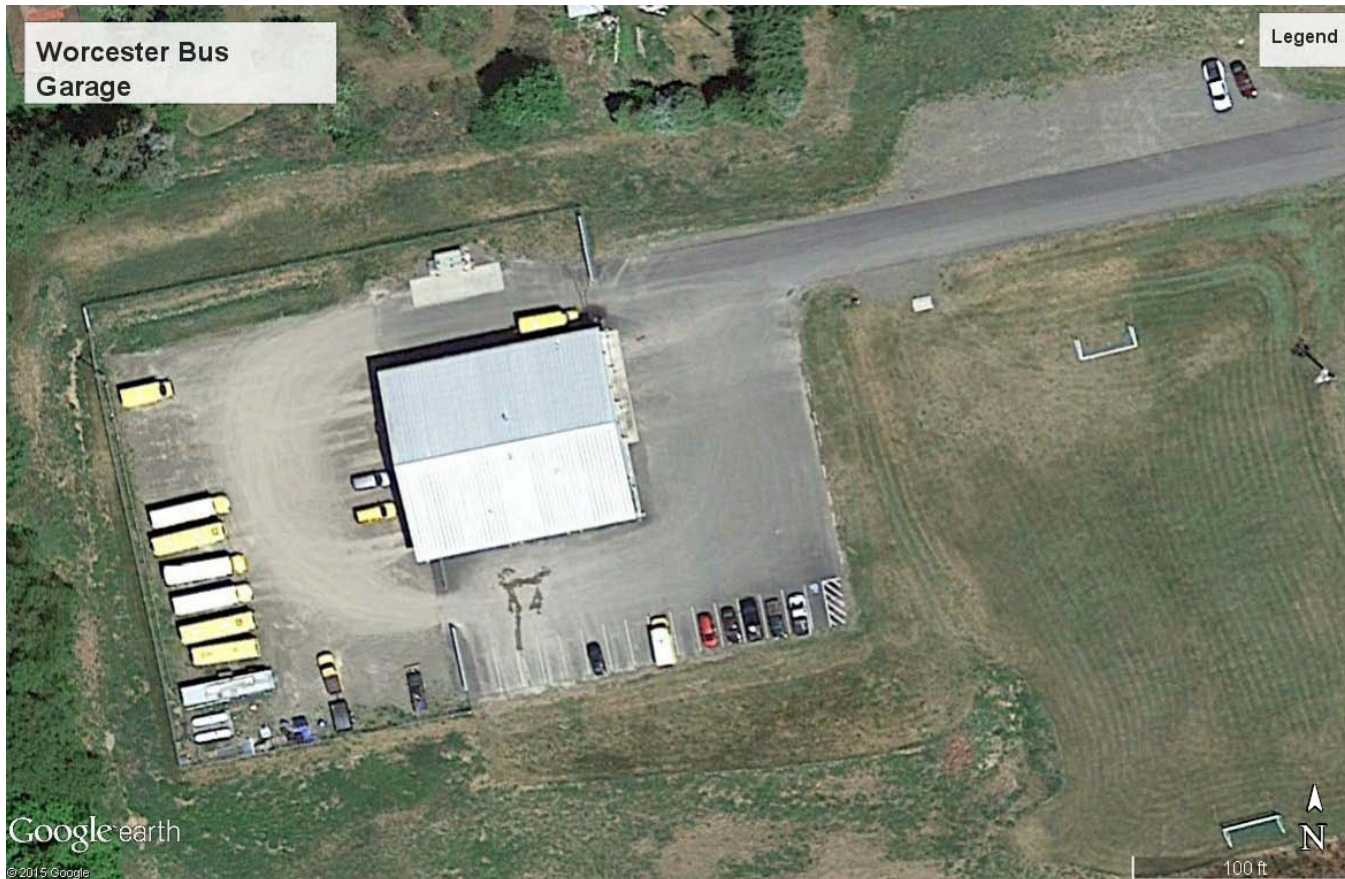
## Bus Garage – Key BCS Findings:

- Add CO detection to meet current NYS code - *estimated at \$10,000.*

- Add emergency battery-backup power wall packs throughout the building to provide egress path – *estimated at \$18,000.*

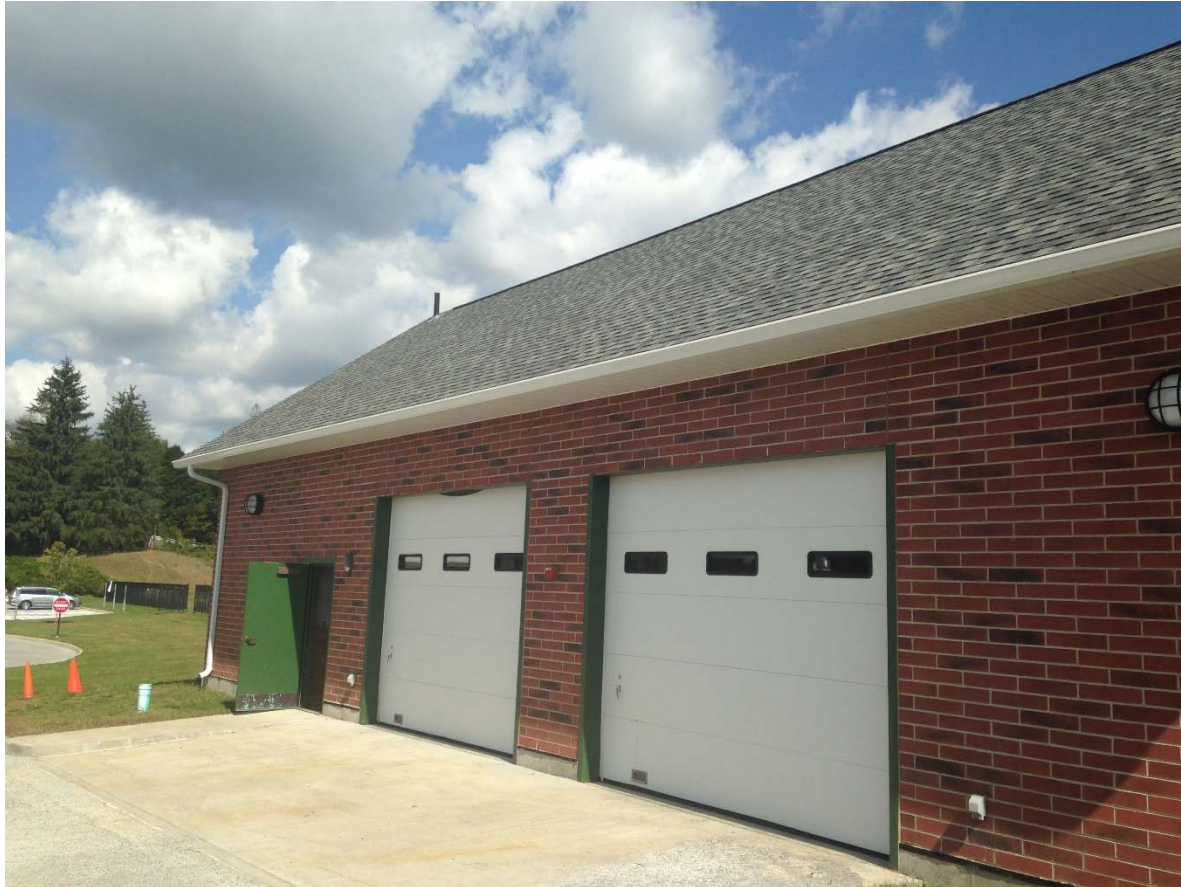
## Storage Building – Key BCS Findings:

- Add CO detection to meet current NYS code - *estimated at \$500.*
